## **NASA Helps Keep the Light Burning for the Saturn Car Company**

# NASA Provides Assistance to Saturn Car Company

#### *NASA Helps Saturn Car Company with Hood Lamp Problem*

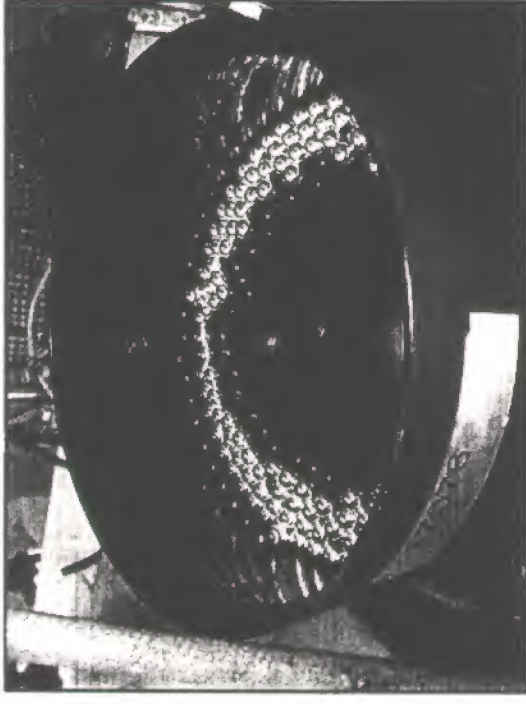
Cleaning materials and concentric wear of silver balls caused a leaching effect of the carbon-based liner within the hopper, thus causing a carbon build-up on the ball bearings and intermittent failures in the under-hood lamps.

- Laboratory tests indicated the problems were caused by a build-up of carbon-based contaminants on the switch components – namely the silver-plated balls.
- NASA identified that in the assembly process, the hopper bowl that holds the silver-plated balls was lined with a urethane coating containing 1 percent carbon.
- Tests identified that cleaning products used on the hopper released carbon particles.
- Rotation and agitation of the balls caused wear within the hopper, contaminating the balls at various levels depending on the amount of contact the balls encountered with the liner surface.
- Saturn stripped the coating from the hopper and reduced the load size of silver balls in the hopper.

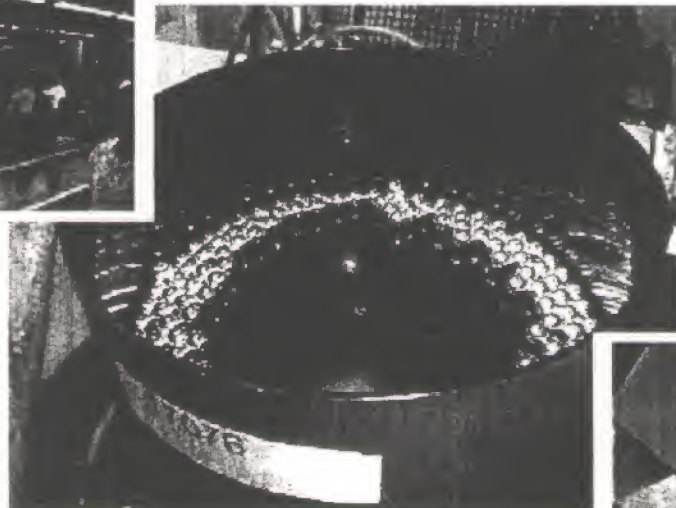
*NASA identified the urethane coating on the hopper, center, contained 1 percent carbon that created buildup on the ball bearings, right, resulting in lamp failures.*

NASA lab researchers determined the hopper bowl was lined with a urethane coating containing 1 percent carbon. The rotation and agitation of the silver-plated balls caused concentric rings of wear within the hopper coating. In addition, the cleaning materials used on the hopper caused a leaching effect of the coating, which also released carbon particles.

These particles then lodged onto the surface of the silver-plated balls through the pressures exerted from the multiple layers of balls in the hopper. The level of carbon contaminants would vary for each ball depending on the amount of contact with the liner surface area the ball encountered – this caused intermittent failures in the final lamp assemblies at an unpredictable rate.

NASA recommended that Saturn remove the liner coating from the hopper bowl and reduce the load size of silver-plated balls placed in the hopper. Fewer balls in the hopper bowl will reduce surface-wear due to less pressure exerted on the balls at the bottom of the hopper.
